Manhole Inspection Summary

Manhole # S51AA_015MH

Insp Date: **2/18/10 3:42 PM**

Location Address: **701 Curley St.**

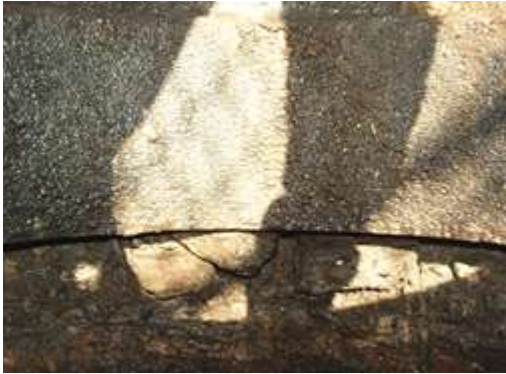
Defect 5

Condition: ☐ Sound ☐ Cracked ☐ Root Intrusion ☒ **Loose Brick** ☒ **Deteriorated**

loose bricks

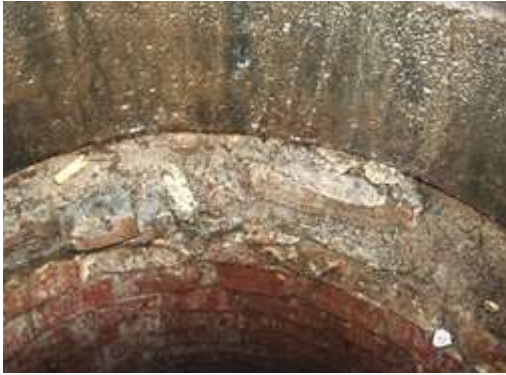
Defect 4

loose bricks

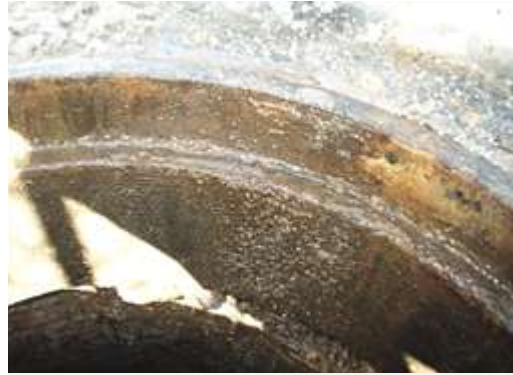
Defect 3

☒ **Leaks**

frame leaks

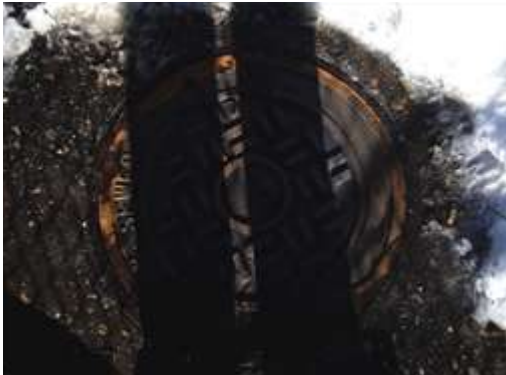
Defect 2

new cover

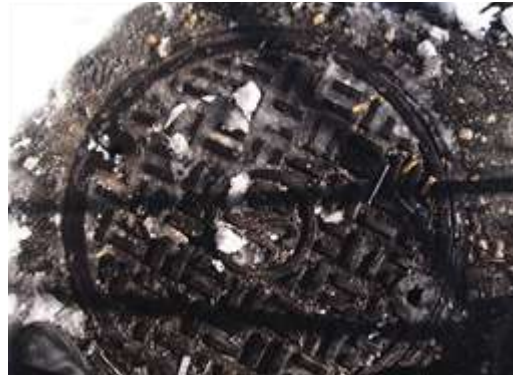
Defect 1

cover

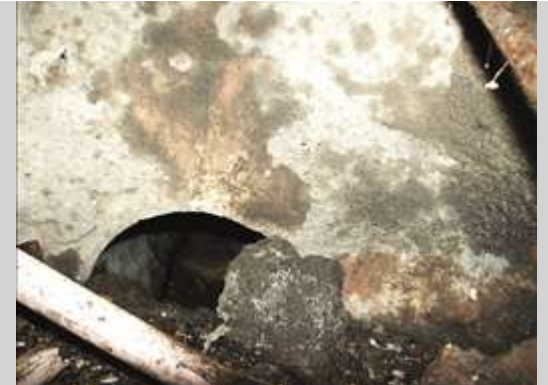
12 O'Clock Outflow

8 in. Circular Gravity Sewer
Pipe Out @ 12 O'Clock

Deposits: ☐ None ☒ **Mud** ☐ Sludge ☒ **Debris** ☐ Grease

Silt Depth: **4** (in.) Deposits Extent: **Heavy**
